Analysis of high-k HfO_2 and HfSiO_x dielectric films

Charles Evans & Associates/
Evans Analytical Group

Wesley Nieveen
Scientific Fellow
April 16, 2003

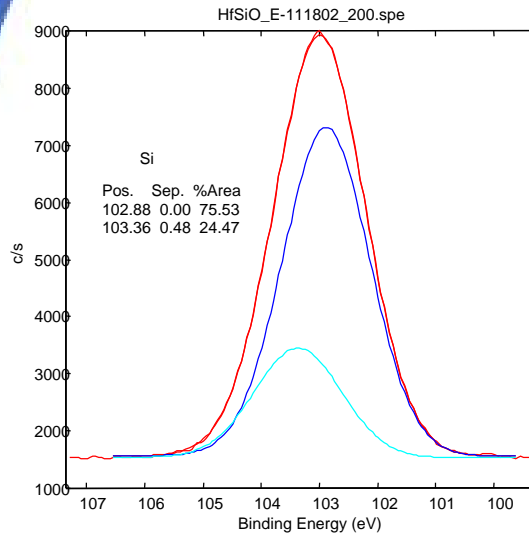
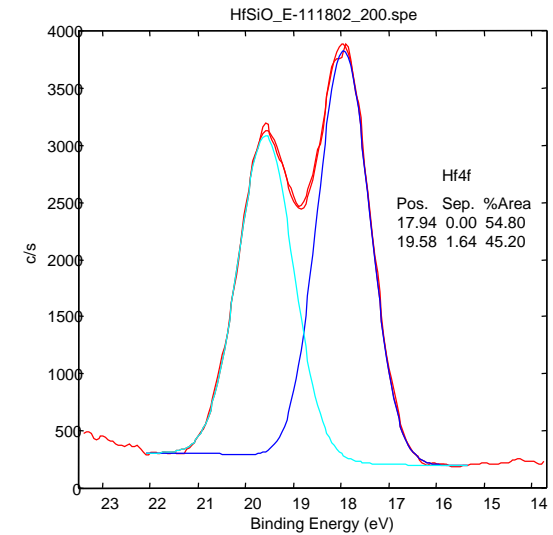
Composition and stoichiometry of HfSi_xO_y films are much more difficult to determine.

n	Atomic %
n	O1s 63.7
n	Si2p 20.8
n	C1s 10.6
n	Hf4f 4.9

- Non-silicate O unclear
- Si suggests either
 1. 2 silicate forms
 2. Silicate + SiO_2
- Hf4f indicates single Hf state

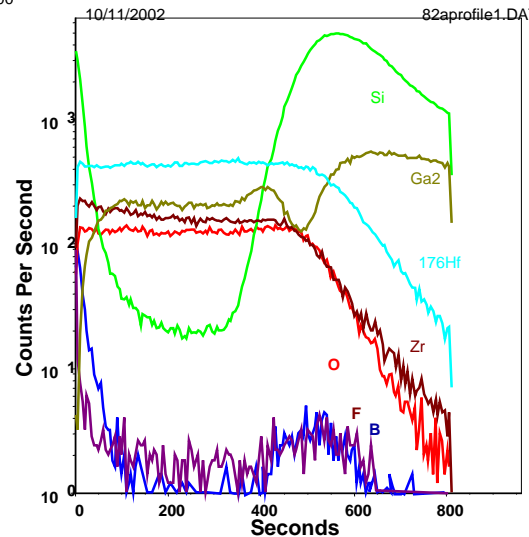
Profiles of ~8.6nm
HfO₂ film on Si
(with interfacial
SiO₂ layer)

AES profile, 5keV
e⁻ 4 keV Ar⁺

TOF-SIMS profile
15keV ⁶⁹Ga

XPS profile
4keV Ar⁺

All techniques exhibit
severe 'tailing' of the
Hf into the Si substrate.

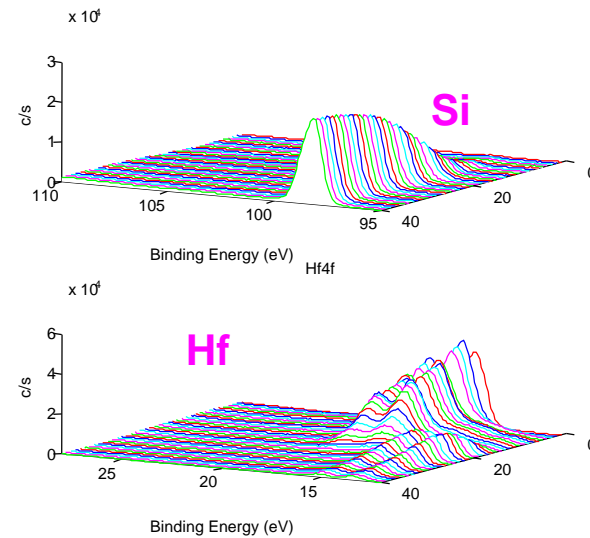
XPS Depth Profiles of HfO₂

Hf metal appears at/near the Si-HfO₂ Interface.

Chemical state profile

XPS profiles of 86Å HfO₂ clearly show the presence of Hf⁰ in the Si substrate.

B.E. are consistent with HfO₂, Hf⁰, Hf sub-oxides.

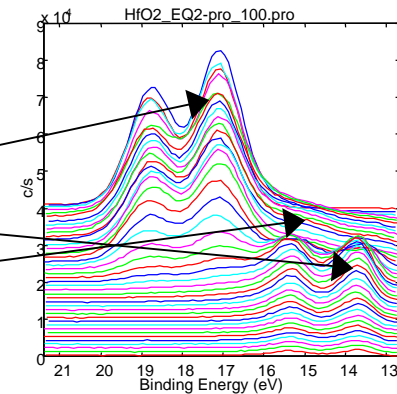
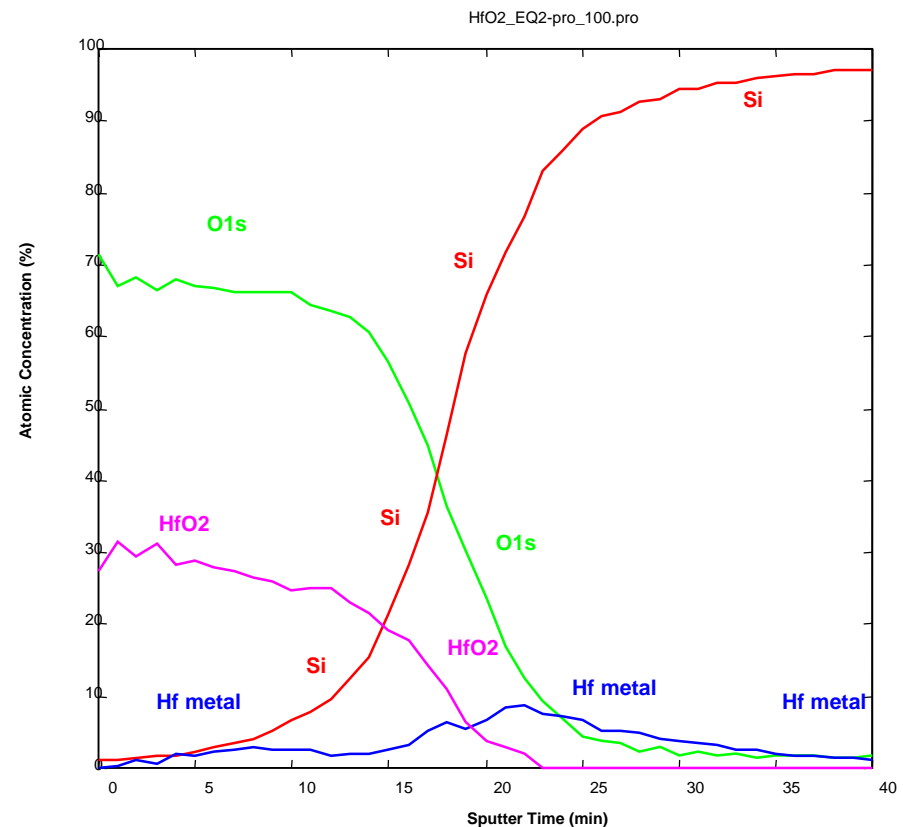
Chemical State XPS Profile of 86Å HfO₂ film on Si.

- n NLLS fit using Hf4f as HfO₂ (@16.3eV) + Hf4f as Hf⁰ (at 13.8eV)
- n Thin interfacial SiO₂ estimated at 5-7Å present (but not shown for clarity)
- n Hf-sub oxides present in HfO₂ film shortly after sputtering starts. Sub-oxide component partially overlaps Hf⁰ component within layer.

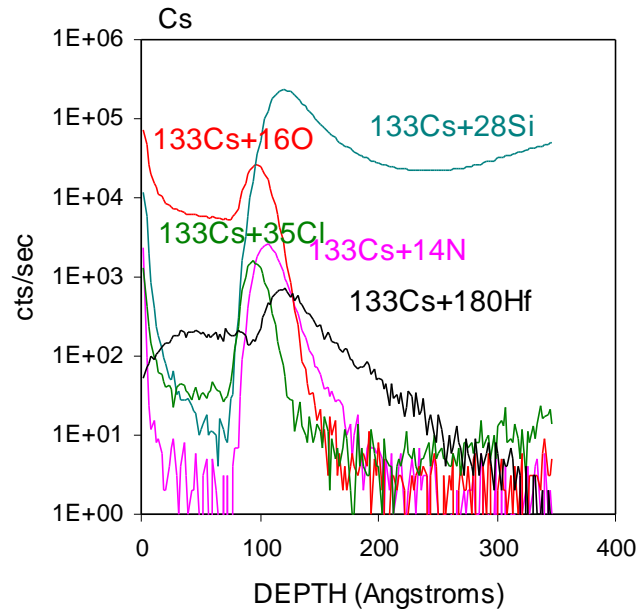
Examples

n SIMS

- CsM⁺ shows strong tail,
- M⁺ has less pronounced tail.
- M+O is self-fulfilling profile

n XPS

- ALD film with high C content
- w/ C, tail extent is reduced (compare to no C).
- Tailing inversely proportional to N doping?

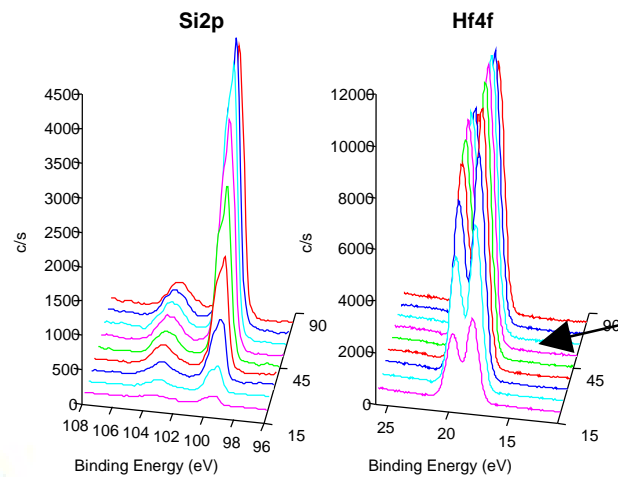
n ARXPS of 40Å HfO₂ layer.

v No evidence of Hf metal present in the sample.

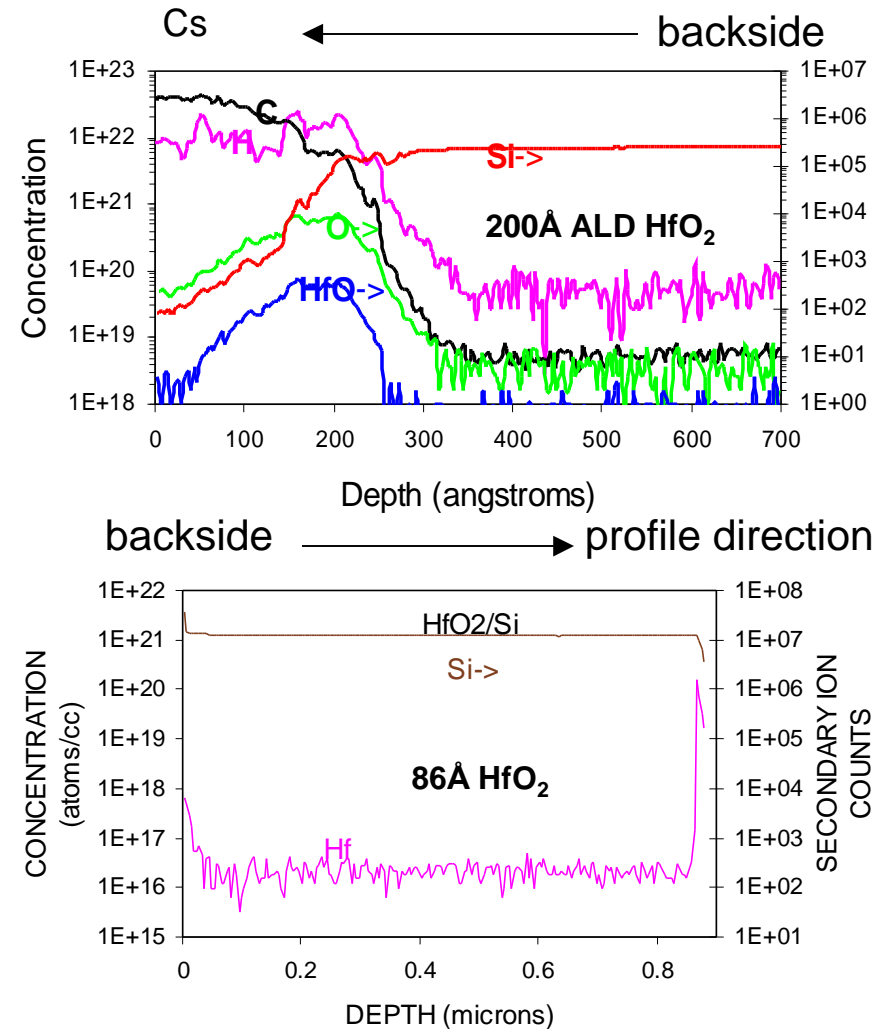
Is 'tailing' real or not? Test 2

- n Backside SIMS, i.e. a reverse profile from the Si substrate into the HfO_2 film.
- n Requires special sample preparation a'la TEM x-section; thin HfO_2 films on Si are glued face-to-face then backside thinned.

∅ **Backside SIMS shows no Hf in the Si substrate!!**

- n 'Tailing' of Hf into the substrate in ion sputter profiles is simply an artifact of the sputtering process.
- n ARXPS of thin HfO₂ films demonstrates that there is no metallic Hf present at or below the interface, but ion sputter profiling of the same sample shows extensive Hf metal tailing.
- n Backside SIMS demonstrates (with superior detection limits to XPS) that Hf does not exist in the Si substrate.

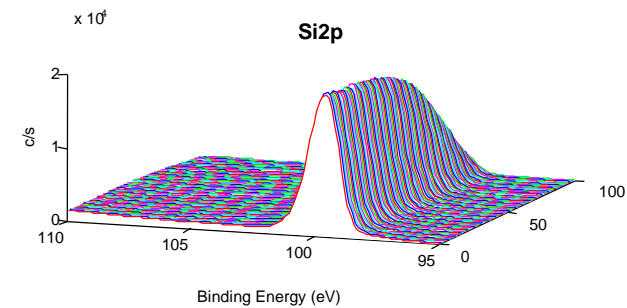
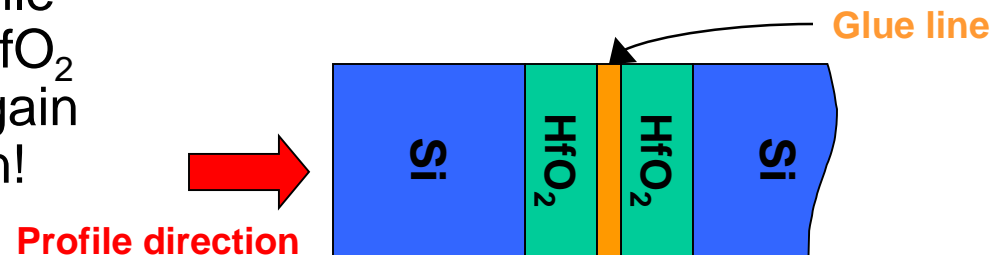
Is 'tailing' real or not? Test 3

- n *Coup de grace* is XPS backside profile of HfO₂ film.
- n No Hf metal is observed in the Si substrate.
 - Note however, that due to DOI (IMFP, EAL), Hf as HfO₂ begins to appear within Si region.
- n Continuation of profile through glue line, HfO₂ layer, and into Si again shows Hf⁰ formation!

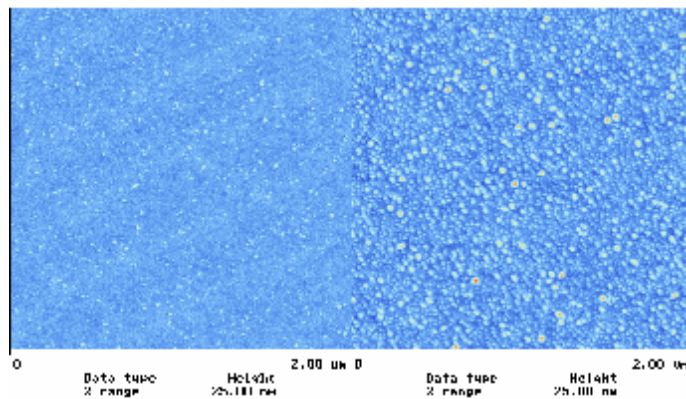
Top of sample Bottom of crater.

$$R_a = 0.53\text{nm}$$

$$R_a = 2.52\text{nm}$$

- Roughening by the ion sputter process does not account for the long depth of penetration by the Hf into the Si. (see also Sematech AVS presentation).
- Large mass difference between Hf and Si plus large differential sputtering, knock-on, localized heating, etc. may result in Hf 'dissolving' into Si. Analogous to Au on Si profiles.

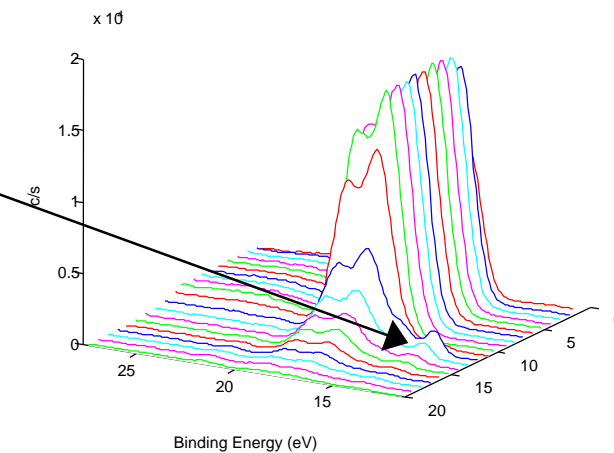
Addition of Si: Profiles of HfSiO

- n Profiles of thin hafnium silicate layers behave differently than HfO_2
- n Behavior depends on Hf-to-Si ratio
- n Regardless of Hf:Si ratio, at interface, Hf metal is seen but tail extent is usually small. (compare to HfO_2 profile).

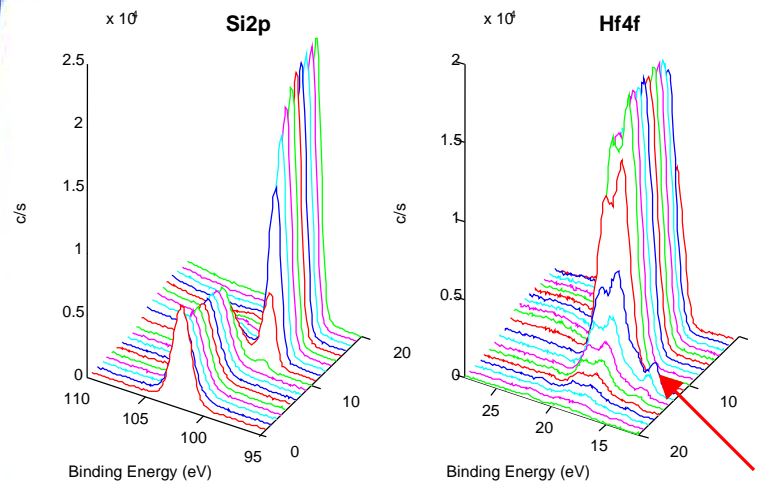
Hf:Si \approx 1:2

n At Hf:Si <1:

- Hf remains as HfSiO₄ through the film.
- **Hf forms Hf⁰ at interface but tailing is usually short.**
- Si as silicate (102.5eV) is ~const. through film.

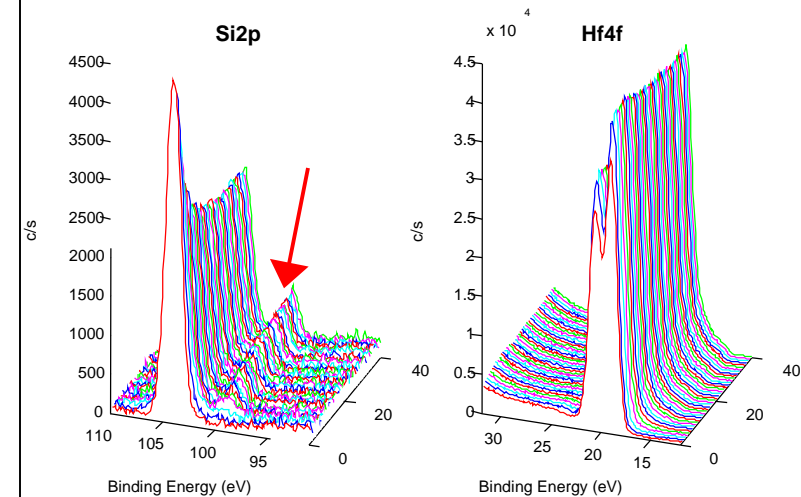
Hf:Si \approx 2:1

n At Hf:Si >1 (?):

- Hf remains as HfSiO₄ through the film w/ small sub-oxide.
- **Shortly after sputter, Si shows silicate/oxide + Si⁰!!**
- **Hf scavenges O from Si to maintain HfSiO₄!!!**

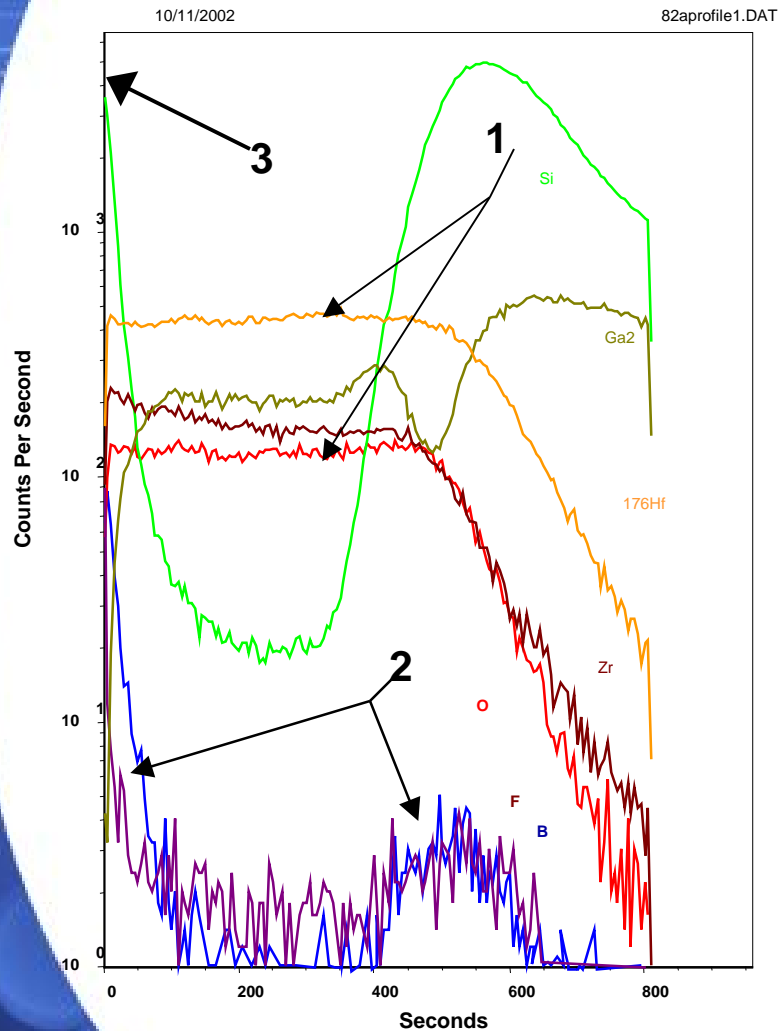
Other 'artifacts': Anomalies in TOF-SIMS of HfO₂

- n Nominal 86Å HfO₂/Si film (by MOCVD?).
- n Test of TOF for profiling composition:
 1. Hf and O are flat through the layer – minimal matrix problems - maybe.
 2. TOF shows a surface and interfacial F layer + high Zr impurity.
 3. (anomalously high) TOF suggests that there is a high surface Si concentration.
 4. Acquisition conditions not optimized?
